Disaster-resistance profile of donor-provided post-*Durian* dwellings in Albay, Bicol Region: Inputs to sustainable mass housing programs

Arch./Enp. Sylvester Shaun D. Seño^{1,2}

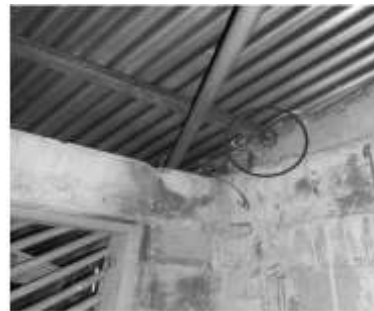
Actual site inspection and photo documentation however indicate deterioration of steel roof purlins for the COPE housing design variant (see **Figure 3**), while the rest of the housing design variants have normal wear and tear on its wooden members (if there are any) like doors and windows due to exposure to harsh weather elements.

Figure 3. Broken Steel Purlins of COPE Housing Design Variant brought by rusting of members due to monsoon rains (encircled)

3. The waterproofing of roofing systems needs to be improved since these pose risks for roofing systems with steel members.
4. There was lack of coordination during the typhoon *Durian* aftermath among the government's public housing arm (NHA) who handled the site selection and land development, with that of the housing donors (NGOs including another government agency, DSWD), and that of the housing beneficiaries due to the exigencies of the situation.
