Presented at the DLSU Research Congress 2014  
De La Salle University, Manila, Philippines  
March 6-8, 2014

## Infrared Thermal Image Profiling for Gearless Hoisting Motor Condition Monitoring

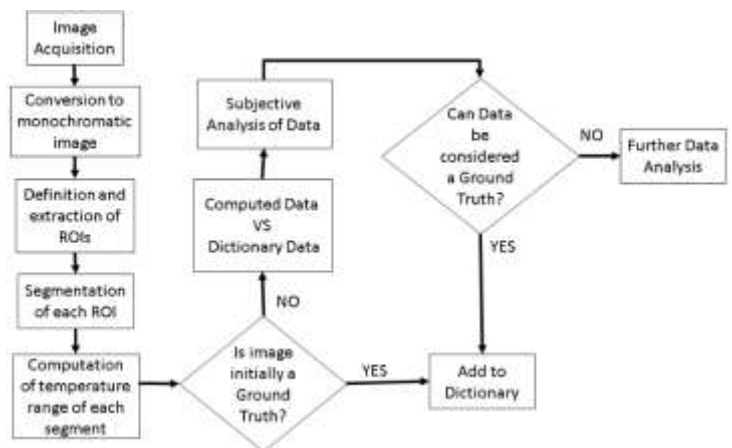
Fig. 3.1. Block Diagram of the System

First, the thermal images were acquired through an infrared thermograph (IRT). These images are initially produced in monochrome through the IRT's default settings but are visually modified into various color palettes, such as *High Contrast*, *Hot Metal*, and *Isotherm Style*, available in the IRT's accompanied software application, *ACEZ BG Analysis*. An image's color palette is then set to *White Hot Mono* since it closely resembles a monochromatic outlook of the image and it has a relatively efficient sample distribution based on its generated histogram, as shown below:

The thermal image was input into the system, wherein the system defined the three (3) ROIs in the motor image and extracted each of them. Each ROI is then segmented into predefined dimensions of cells/segments (e.g. ROI 1 – 9 cells long and 6 cells wide). Each segment is then traversed to compute for the minimum and maximum temperature ranges within it, wherein there is an underlying conversion of pixel values into temperature values. After computing for the values, the results are then compared with the current base values in the predefined dictionary of values obtained from previously processed thermal images. If values are within tolerance range, the averaged values are then integrated into the dictionary. Otherwise, the images are disregarded from the system and are reconsidered for subjective analysis.

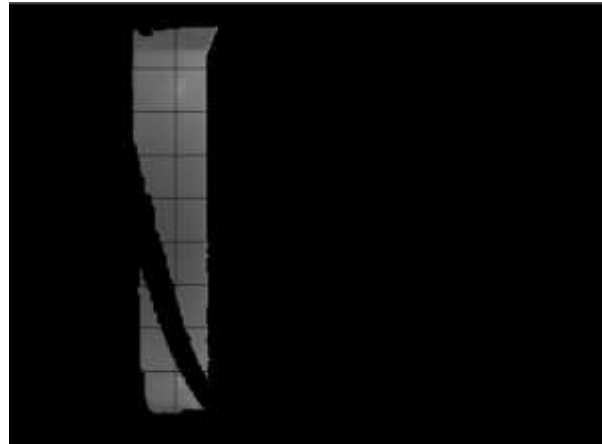
Fig. 4.6. Segmented ROI 2 (2x9; length by width)

Each defined ROI is extracted and dealt with separately. The extracted ROI is then segmented into discrete dimensions of equally-sized cells/segments. The dimensions (length by width) of ROI 1, 2, and 3 are 6x9 cells, 2x9, and 3x9, respectively. This allows dynamic adjustment of the cells' sizes based on the overall size of the entire motor in the image. Also, it allows relative consistency in the values to be computed in each cell. Examples of segmented ROIs are shown in Figures 4.5, 4.6, and 4.7.
