Water Quality in Pampanga River Along Barangay Buas in Candaba, Pampanga

Abstract: Pampanga River traverses the provinces of Nueva Ecija, Pampanga, and Bulacan and is the second largest river in the whole of Luzon with a total length of 260 kilometers. It divides into small branches that empty to several fishponds especially in the town of Candaba. This study aimed to initially identify the physico-chemical characteristics of the river using some parameters such as pH, temperature, dissolved oxygen, ammonia, nitrates, and phosphates. Dissolved oxygen, pH, and temperature were measured using DO meter, pH meter, and thermometer. Chemical tests were done on site using test kits from Aquarium Pharmaceuticals Incorporated (API). It was found that ammonia and phosphate concentrations exceeded the maximum value required by the DAO 34 -Water Quality Standard for Class C Water. The DO concentration was below the minimum requirements for river water.

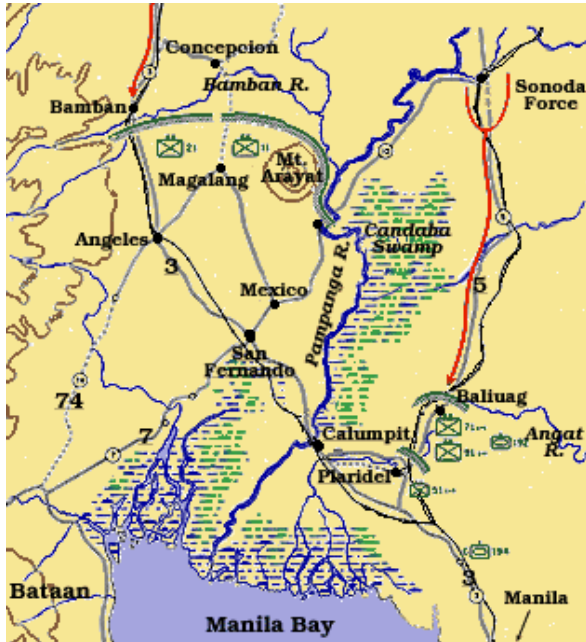
Figure 1. Map of Pampanga River with Candaba Swamp indicated from <https://www.google.com.ph/search?q=Map+of+Pampanga+River>

Pampanga River with a total length of 260 kilometers, is the second largest river in the whole of Luzon (Figure 1). It traverses the provinces of Nueva Ecija, Pampanga and Bulacan. The headwaters of Pampanga River came from the mountains of the Sierra Madre and drains via the Lanbangan Channel into Manila Bay. Pampanga River provides irrigation to about 363,246 hectares of farmlands in the provinces of Nueva Ecija, Pampanga, and Bulacan. The river has small branches that empty to several fishponds especially in the town of Candaba.
